WELLS Counter Point

Volume 7 Issue 4, October 2003

Forming a Diagnostic Strategy Part Two

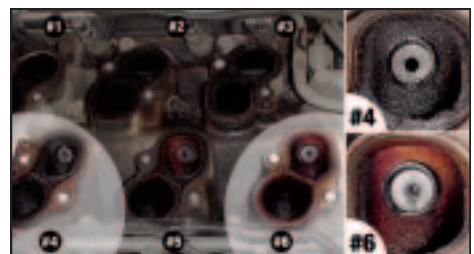
Several EGR ports on this Ford Windstar 3.8L V-6 were clogged. Consequently, all flow was directed to #1 and #4.

The photo above shows what we found after removing the upper intake manifold. The EGR port orifices leading to cylinders 2, 3, 5 and 6 were plugged. As the EGR opened at or near cruising speed, all of the exhaust flow went to cylinders 1 and 4 because they were the only ones with open EGR orifice ports. This caused the air/fuel ratio for these cylinders to become an incombustible matter.

While we had found the cause of the misfire, we still needed to find the reason why the EGR orifice ports had become clogged with carbon. The higher than normal CO reading on

the five gas was a clue. A high CO level in the exhaust indicates a rich running engine. Before reinstalling the upper intake manifold, we decided to perform a quick fuel pressure test. The pressure was good, but the gauge would slowly leak down. We removed the injectors from the lower intake manifold but left them connected to the rail. We again energized the fuel pump to pressurize the fuel system. Sure enough, we could see the number 6 injector was leaking a little. This would cause an excessive amount of CO in the exhaust, which over time was the probable cause for the carbon buildup blocking the EGR orifice ports.

Results: After making the necessary repairs, the engine ran great and the NO_x and CO levels in the exhaust returned to normal.

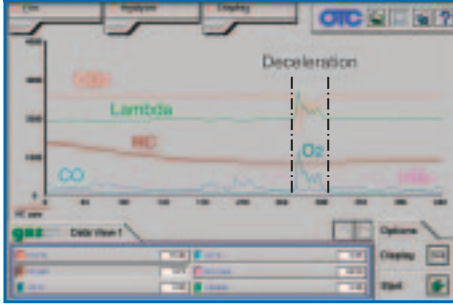
We've welcomed many new *Counter Point* subscribers since July, so **Figure 1** (showing all five exhaust gases in graph form) is repeated on page 3. The graph begins with a cold engine start. HC is higher than normal in the early frames and gradually declines. There was an abrupt

deceleration between frames 264 and 308. When this occurred, NO_x went down, O₂ went down, Lambda went up and CO₂ dipped (showing a lean mixture). HC reduced slightly but stayed about the same (still too high) and steadily declined.

All of the readings captured during the deceleration are consistent with a lean mixture, except the high HC reading. We would expect to see a lean mixture, because the injectors should be closed and all fuel should be cut during closed throttle deceleration. But the high HC reading indicates the presence of unburned fuel. This would seem to indicate that the engine was running rich and lean at the same time, which is impossible.

One possible explanation for this conflicting set of five gas readings was that the extra, unburned fuel (HC) was already in the exhaust before the engine was started. This would also explain why the HC reading gradually declined as the engine warmed up and burned off the extra fuel. But where was the extra fuel coming from and how could it be getting into the exhaust system before the engine was started?

Figure 1: Before repairs, HC emissions remained high from cold startup, through acceleration and into closed throttle deceleration. The fuel had to be coming from someplace else during decel because the injectors were turned off.

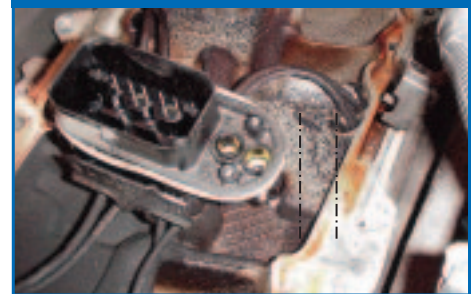
Based on our scan tool and five gas information, we decided it was time to remove the intake manifold and have a look. What we found is shown in **Figure 2** (also on page 3). As you can see, the rear half of the engine was wet with fuel, which may have been leaking from the central point unit, its hoses or the poppets. It appeared that number 5 cylinder hose or poppet was the source of the leak, but everything was so clean that we could not be absolutely sure. This extra fuel flooded the valley area, seeped past the O-rings around the poppets and found its way into the cylinders while the engine was off. When the engine was started, most of the extra fuel passed through unburned into the exhaust system. As the engine had an opportunity to run, the catalysts began to heat up and burn off the excess fuel. The extra heat in the catalysts was probably what destroyed them in the first place. Remember, the first shop had replaced both the cats and all four O₂ sensors.

Figure 2: The rear of the engine was wet with fuel, either due to a leak at the #5 poppet or at the CSFI unit. Everything was either resealed or replaced to prevent further problems.

Because we could not be absolutely certain which fuel system component was responsible for the leak, we replaced all of the CSFI components under the intake manifold. This wasn't a job that we wanted to do twice nor did we want to risk killing another cat. After everything was back together, we returned the vehicle to the customer. We allowed him to drive it for a while, then asked him to return so we could recheck the scan data and emissions. The long term fuel trim numbers were much closer to normal (124) and short term fuel trim for both banks were right on
