## TECH INFORMATION FROM CLEVITE ENGINE PARTS

TB-2043

### THRUST BEARINGS

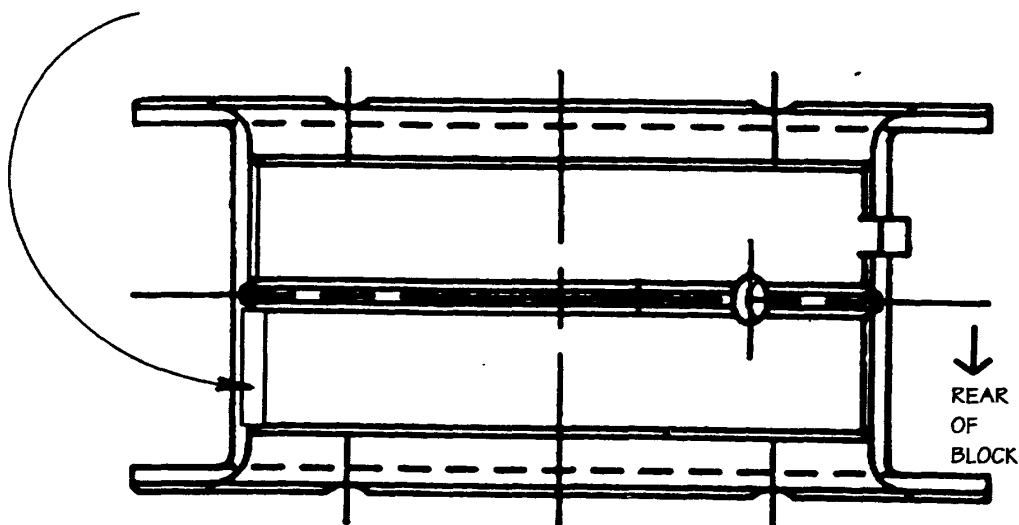
#### **INCREASE PARTING LINE INSIDE CHAMFER TO APPROXIMATELY .040" FROM GROOVE TO REAR ONLY**

A simple modification to the upper thrust bearing may help in problem applications. Install the upper thrust bearing in the block to determine which thrust face is toward the rear of the engine.

Using a small, fine tooth, flat file, increase the chamfer on the ID edge of the bearing parting line from the oil groove to the rear thrust face only. (See diagram.) This enlarged ID chamfer will allow pressurized oil from the bearing oil groove to reach the loaded thrust face without passing through the bearings clearance space first. Since there is a load against the rear thrust face, oil flow should be restricted by the load and there should not be a noticeable loss in oil pressure. Although this modification is not a guaranteed cure-all; it should help if all other conditions, such as surface finish, alignment, cleanliness and loading are within reasonable limits.
