WELLS Counter Point

Volume 6 Issue 3, July 2002

OBD II...Catalyst Monitors

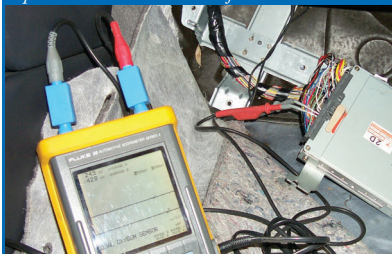
Figure 1: Backprobing wiring harness at PCM to capture dual trace HO2S waveforms
